# I<sup>2</sup>C communication errors on a 17-slot ELMA crate

January 7, 2013

Theodor-Adrian Stana (CERN/BE-CO-HT)

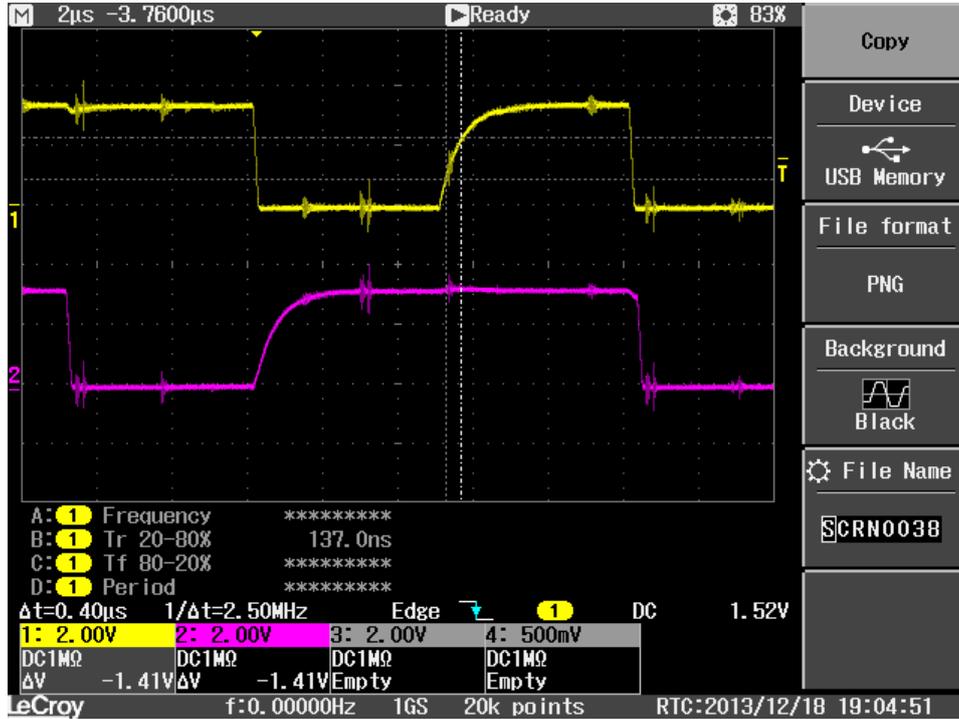
Figure 1: Scope capture with an empty bus

We notice a 30%-70% rise time of 400 ns. This yields (according to equation (1) in the I2C Specification [3] and considering the 2.2 k $\Omega$  pull-up resistors) a bus capacitance of 214.58 pF/in:

$$C_{bus} = \frac{400ns}{0.8473 * 2.2 k\Omega} = 214.58pF$$

Some ripples can also be noticed in the SCL and SDA signals. These will be addressed in a later section.

Each time one CONV-TTL-BLO is added to a VME slot, the rise time increases by 40 ns. This yields a capacitance of **21.46 pF** for a CONV-TTL-BLO.

Finally, with all seventeen slots fully loaded, we have a 30%-70% rise time of **1160 ns**, which is above the I2C specification for maximum rise time of 1000 ns.

Considering that we cannot change the capacitance on the bus, we tried to decrease the pull-up resistance value to decrease the rise time, thereby potentially avoiding the communication errors.

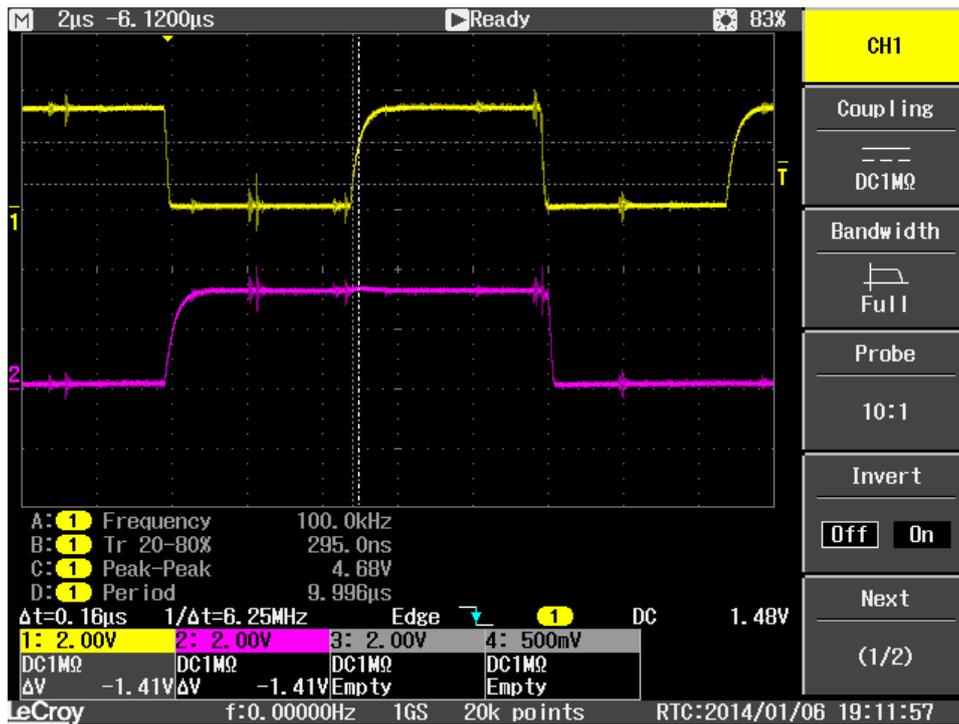
Figure 2: Scope capture with an empty bus and 1.1 k $\Omega$  pull-up resistor

As expected, the rise time is decreased, due to decreasing the pull-up resistance. With all seventeen cards plugged in, the rise time on the SCL line is 440 ns, well within specification (1000 ns).

Also with all seventeen cards plugged in, on this run of the test, the communication presents no more failures, therefore decreasing the pull-up resistance helps with the communication.

We therefore placed a 1.8 k $\Omega$  resistor on the I2C adapter to bring down the pull-up resistance to 0.99 k $\Omega$ .

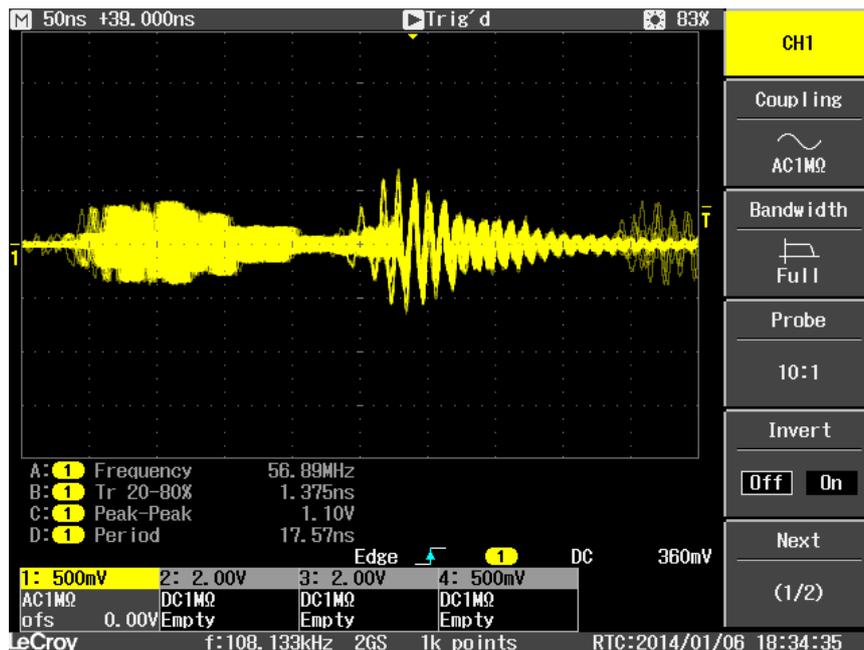
Figure 3: Ripples on SCL line

Figure 3 shows the oscilloscope capture on the SCL line with the oscilloscope channel set in AC mode and no communication on the line. As can be seen from the figure, these ripples can easily hit 1.5 V<sub>pp</sub>, which means they might cause the SCL line on the bus to sample an incorrect SDA if a ripple occurs on a falling edge of SCL. It is unclear whether these ripples are due to the power supply or due to crosstalk.

In previous experiments, we have noticed before errors occurring on the bus even with a lower pull-up resistance, so it is apparent these considerable ripples indeed affect the communication.

Such errors also appeared on one of our two-slot crates where the I2C communication had been working properly. We then noticed the power supply was heating up. This led us to try to place **22 pF** capacitors on

the SysMon, on the pins intended for the C119 and C122 capacitors in the SysMon schematics. Placing these capacitors removed the errors in communication. Unfortunately, the capacitors were removed from the SysMon to allow for testing the I2C pull-up adapter solution, and traces of this test run do not exist, therefore they cannot be included in this report.

- replace the pull-up resistors on the SCL and SDA lines with 1 k $\Omega$  resistors
- decouple the SCL and SDA lines by placing 22 pF capacitors to ground
